## Historic Framework

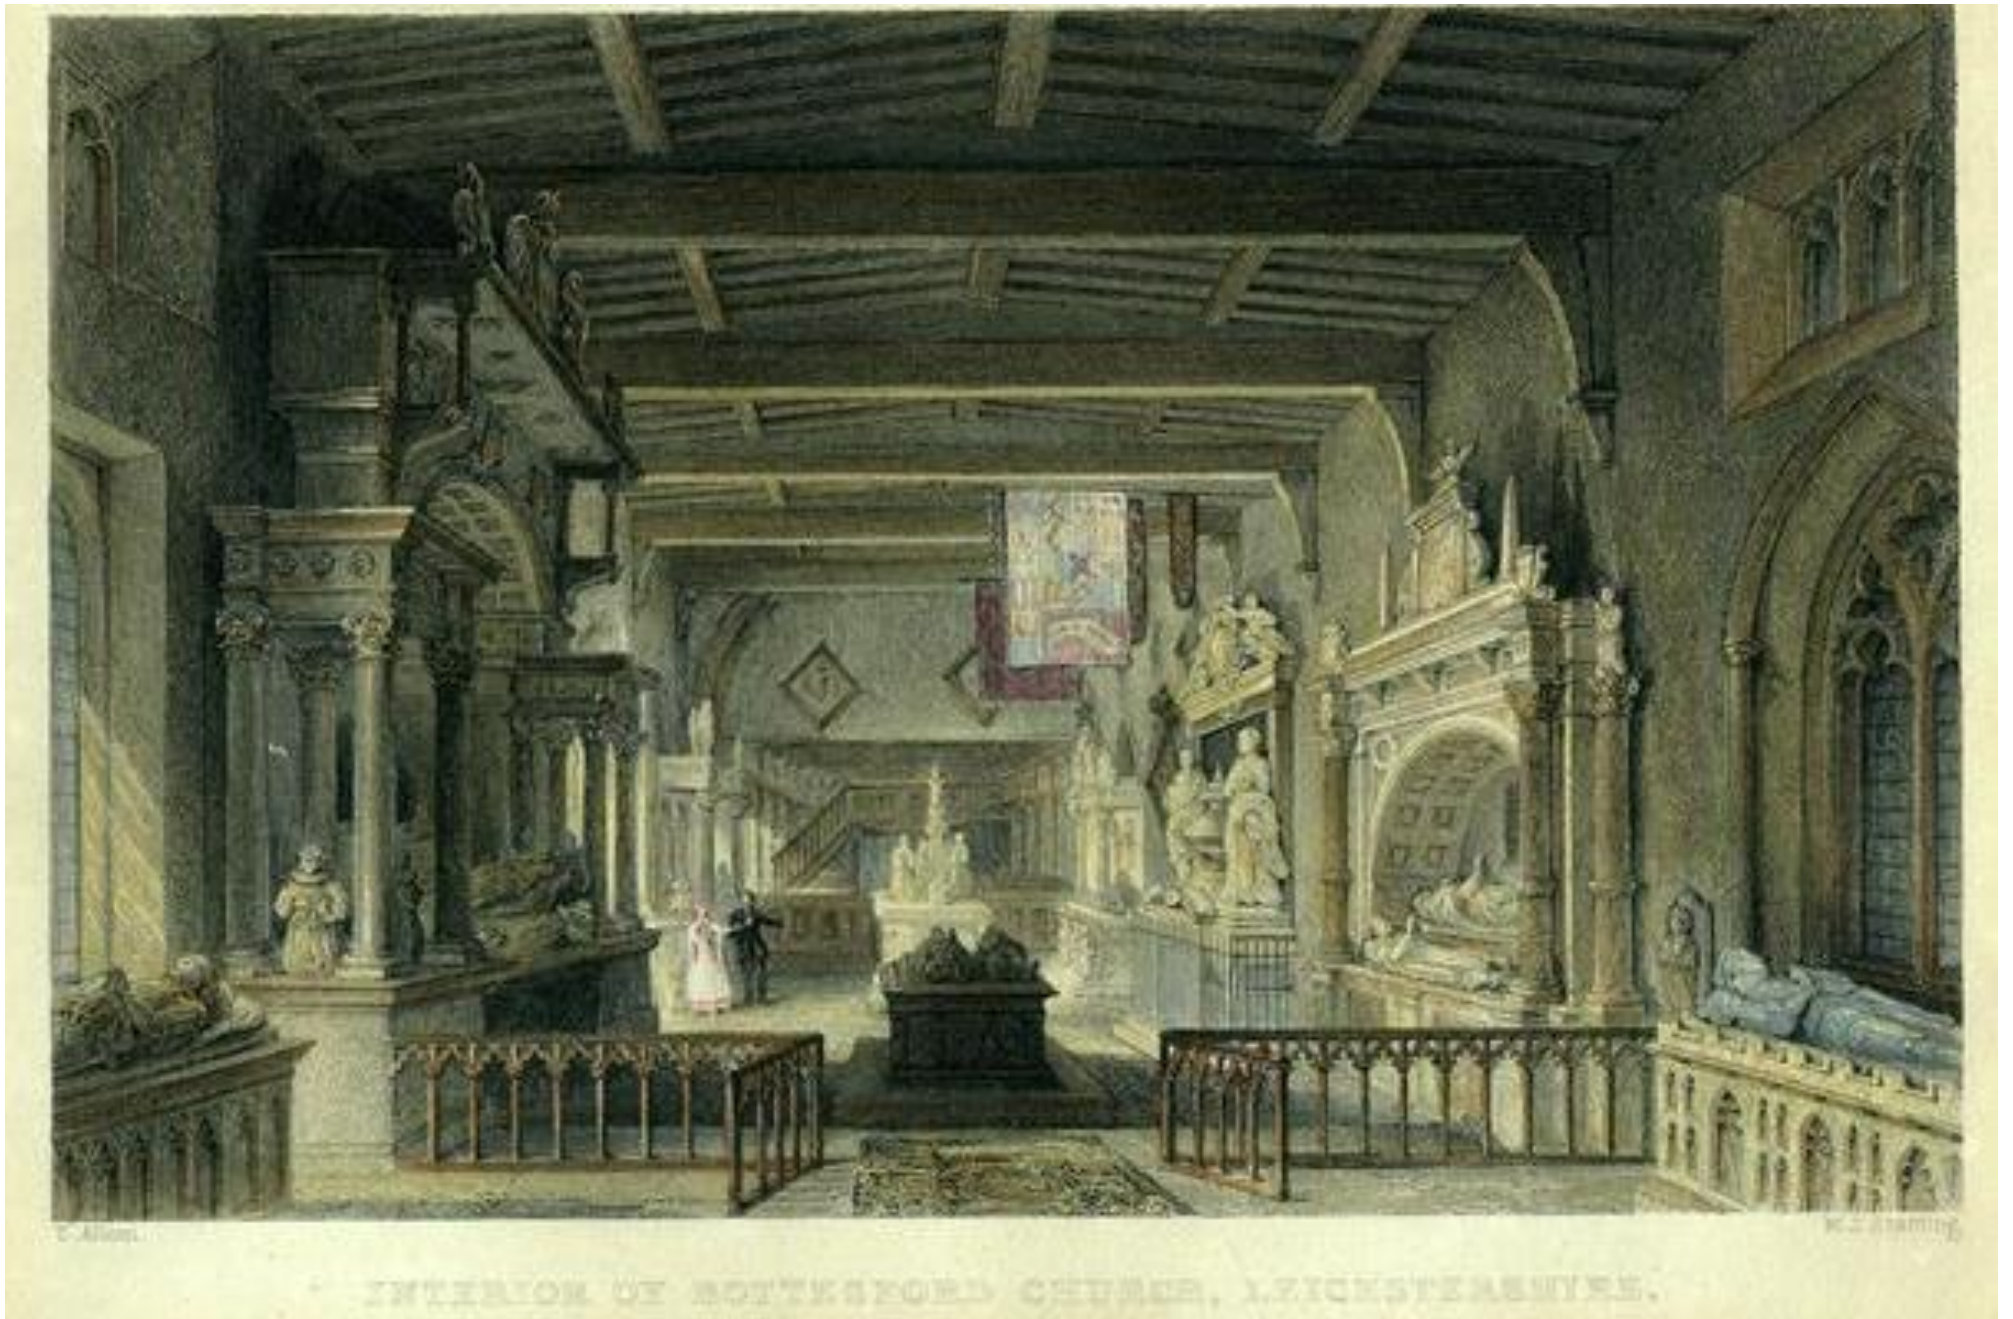
A 19th century engraving of the interior of St Mary's, Bottesford, looking westwards from the high altar.

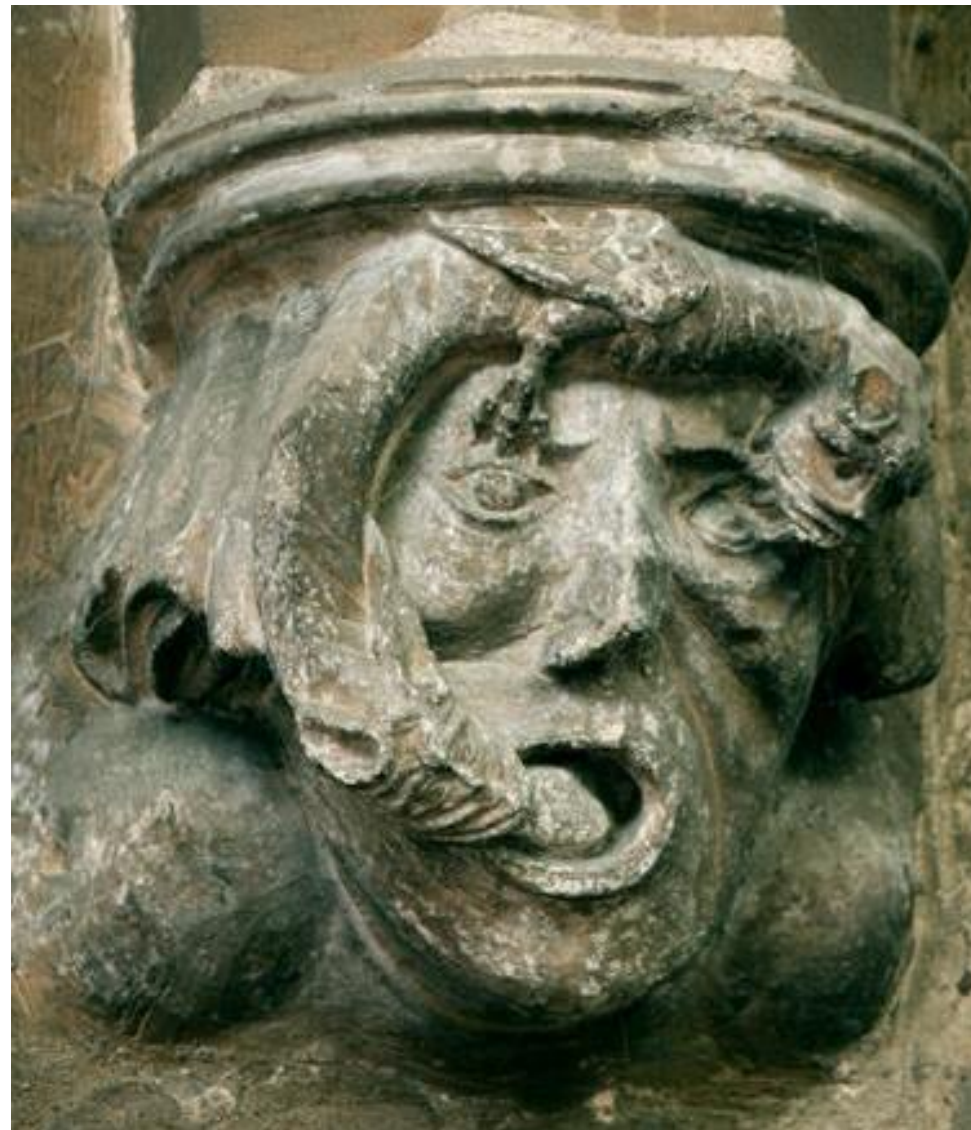
*In the north aisle, we encounter this macabre figure, beautifully carved in what may be Purbeck stone, in contrast to the pale pinkish grey stone of the arches themselves. The dragon's claws, scales and two heads, tormenting the liar, are very detailed.*

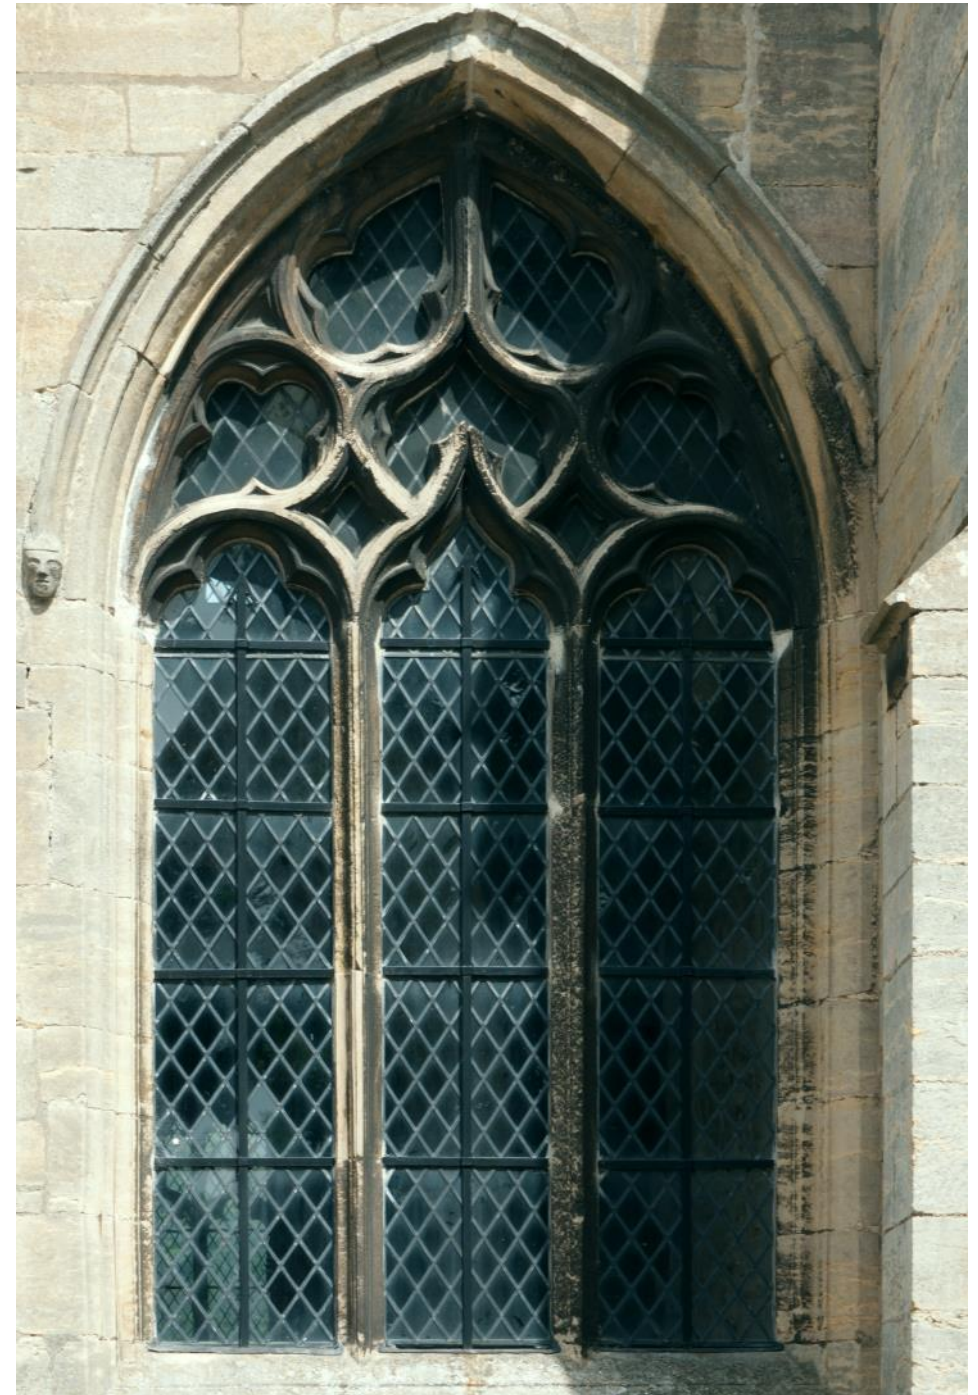
*Window in the south aisle, east of the porch; the right-hand side abuts against the stonework of the reconstructed south transept.*

Other parts of the church are faced in Middle Jurassic oolitic-limestone ashlar, though cruder masonry is seen for instance internally where walls would be dimly lit and hidden by plaster and paint. The windows in the south aisle display curvilinear Decorated gothic tracery of the early 14<sup>th</sup> Century. The porch is also of this age, with small Decorated windows in its upper level indicating that there was once a 1<sup>st</sup> floor room (a parvise): the Perpendicular external doorway is too high to accommodate the floor of this chamber, which may have been removed before the doorway was inserted.
